SERVICE LETTER
NON-APPROVED MODIFICATIONS OR
USE OF ROTAX® UNAPPROVED ENGINE
COMPONENTS OR ACCESSORIES
FOR ROTAX® AIRCRAFT ENGINES

SL-912-014 R2

SL-914-012 R2

SL-2ST-008 R2

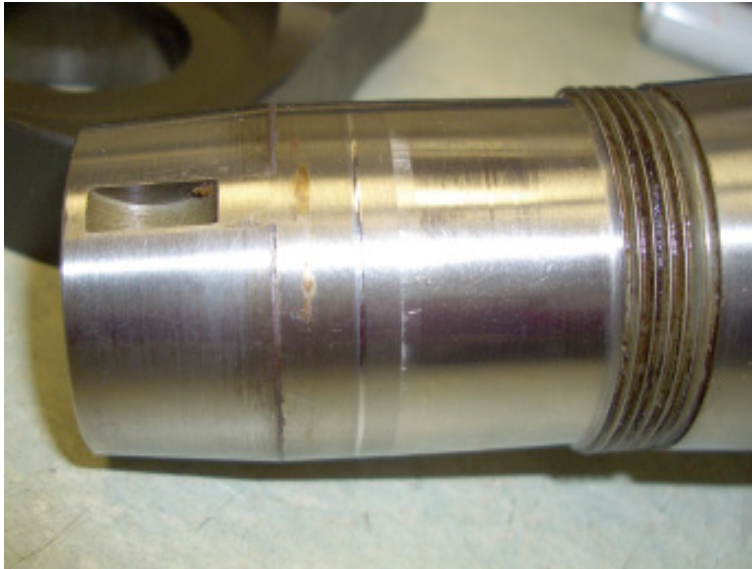
fig. 1

- The crankshaft has a ROTAX[®] part no. 888164 and a serial number (S/N) of S/N 11798, but was not marked as overhauled and shows some serious deficiencies:
 - signs of corrosion in the area of the oil seal (see fig. 1)
 - crankshaft was beyond the out of round limit
 - torque at twist test was below limit
 - a conrod bearing shows signs of wear (see fig. 2)
 - contamination in the oil channels (see fig. 3)

Such a crankshaft is not airworthy and should not be installed or any parts reused according to ROTAX[®]-instructions.

- Ensure before purchase the source and technical release of the part.
- For repaired and overhauled parts request the relevant report and take care that these are documented in accordance with ROTAX[®] instructions.
- For certified parts/engines request further on an Airworthiness Approval Tag.
